**RAMMED MOIST FRESH EARTH - NABÍJENICE / FORMWORK WITH HORIZONTAL TIMBERS PASSING THROUGH THE WALL:: 44 -46** Rammed earth walls of the barn; Spinek (Hodonín) \* **47** Detail of the filling of the hole; Kozojídky (Hodonín) \* **48** Rammed earth barns; Vnorovy (Hodonín) \* **49** Granulometric diagram of rammed earth constructions studied in the project Analysis of historic earthen materials in Czech Republic (J. Kříž 1996 - 1998)

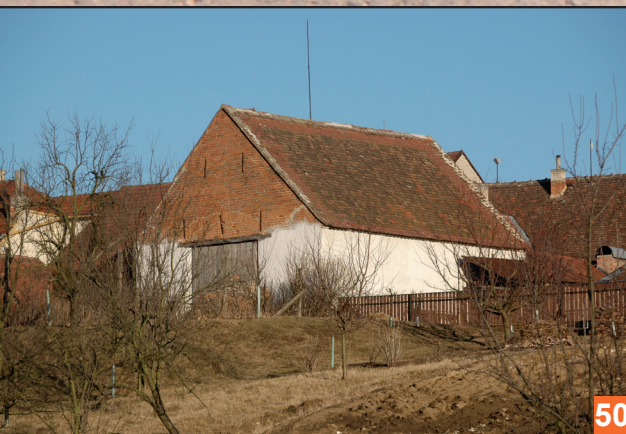
**RAMMED MOIST FRESH EARTH - NABÍJENICE:** 50 Rendered and whitewashed barn; Spinek (Hodonín) \* 51 -53 Barn with remaining pieces of rendering; Spinek (Hodonín) \* 53 - 54 - Details of stone plinth; Spinek (Hodonín), Liděřovice (Hodonín) \* 55 - 56 Details of the wall coping; Liděřovice (Hodonín)

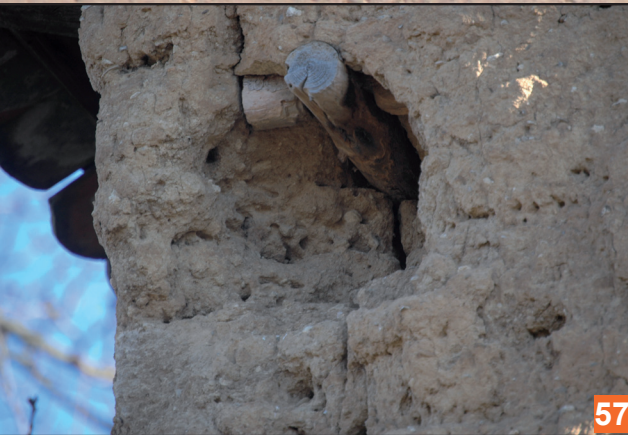
57

**RAMMED MOIST FRESH EARTH - NABÍJENICE:** **57** Reinforcement of the corner; Lidéřovice (Hodonín) \* **58** Reinforcement by wattle; Jankovice (Uherské Hradiště) \* **59 - 61** - Farmhouse; Spinek (Hodonín): detail of the rammed earth visible under the rendering / detail of the cornice from fired bricks
